COOLMASTER OFFICE

External Transmission Oil Cooler Kit Suitable for PATROL PAT

Nissan Patrol Y62 with RE7
7 Speed Automatic Transmission

WITH VK56 - 5.6L V8 PETROL ENGINE (01.2010-2024)

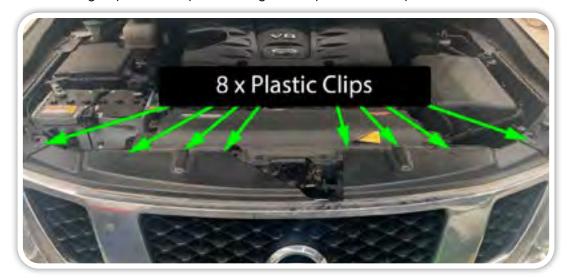
- 1. Remove any bash plates that are covering/protecting the radiator.
- 2. Remove the eight plastic clips holding the top shroud in place.

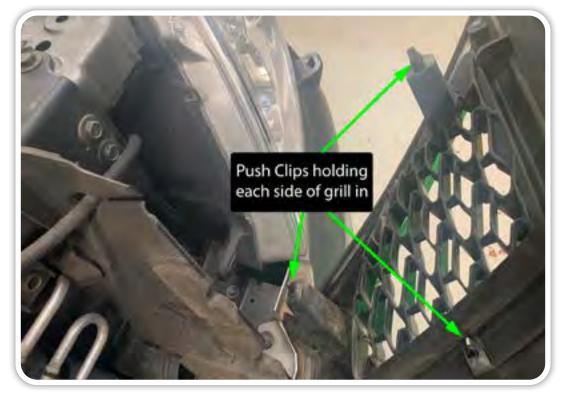
3. Pull forward gently on left and right sides of grill as they are held in with push clips.

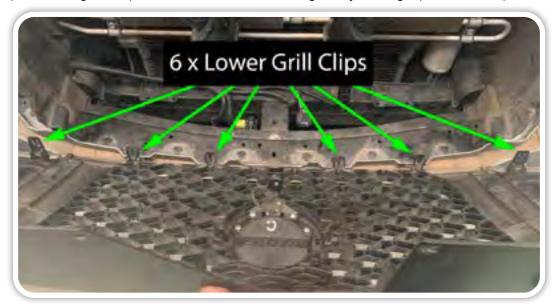
4. Unclip six flat grill clips at the bottom of the grill by lifting up on the clip.

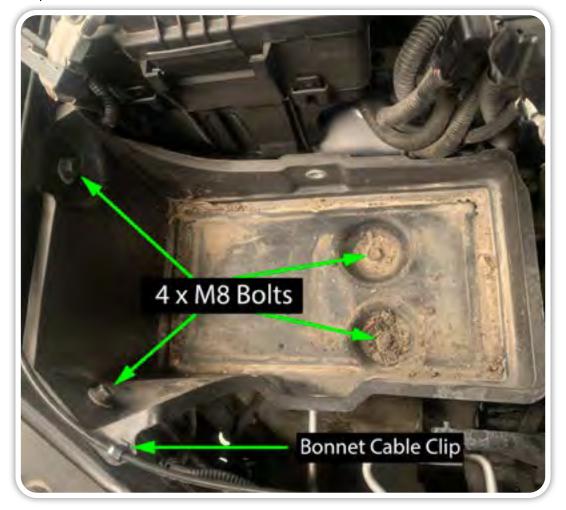
5. Remove battery and battery tray to allow easier access for removing OEM cooler hose and routing new cooler hose. Battery tray is held in by four (4) M8 Bolts and the bonnet cable clip.

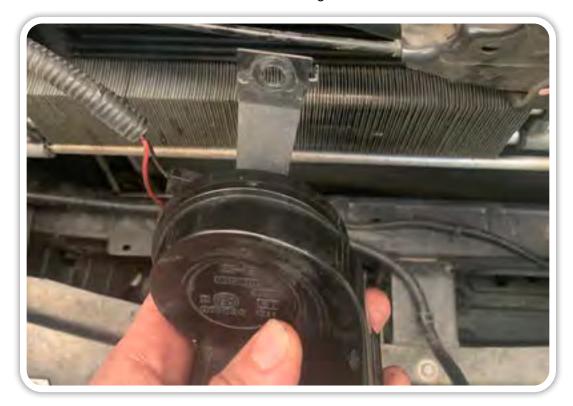
6. Remove the drivers side horn but leave wiring connected.

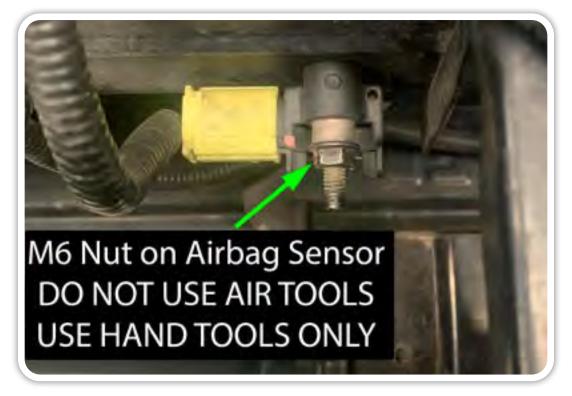
7. Remove the nut off the stud that is mounting the airbag sensor.

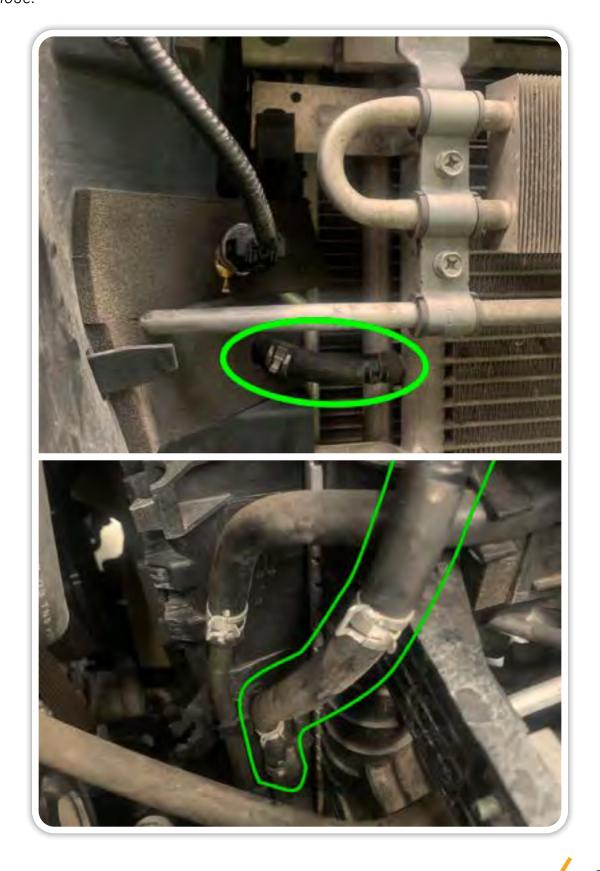
9. Remove clamps off the lower hose of the original cooler. Trace through radiator support to the other end of the rubber line. Remove clamp and then remove the OEM cooler hose.

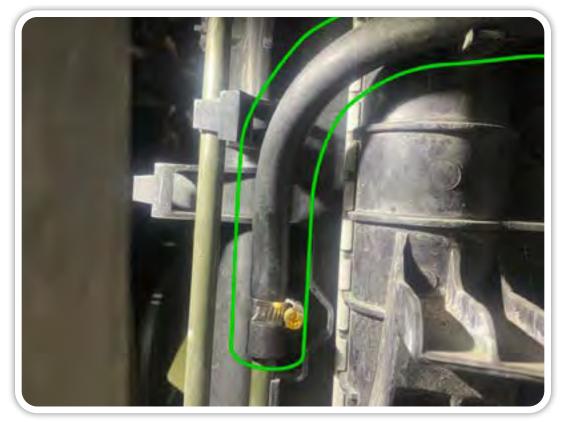
10. Fit new 8mm hose supplied in kit to the OEM in/outlets from removed OEM Hose. (Do not cut new hose into 2 separate lengths yet.)

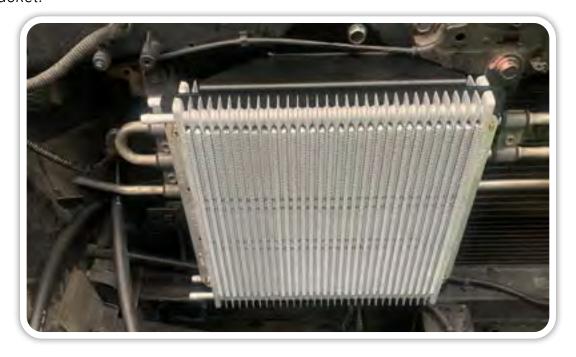
11. Fit the Dual Cooler bracket (with barbs facing the drivers side of the vehicle) to the original horn mounting hole, airbag sensor stud and to the flat section of the radiator support. The radiator support uses a M6x20 SEMS bolt fed from underneath up into the bracket.

- Remove lower hose of the original cooler
- Fit new 8mm hose supplied in kit. (Do not cut into 2 lengths yet)
- With hose in/outlets facing the drivers side of the vehicle, mount the cooler to the original horn mounting hole (OEM Bolt), Airbag Sensor stud (OEM Nut), and the flat section of the lower radiator support (supplied M6x20 SEMS bolt).

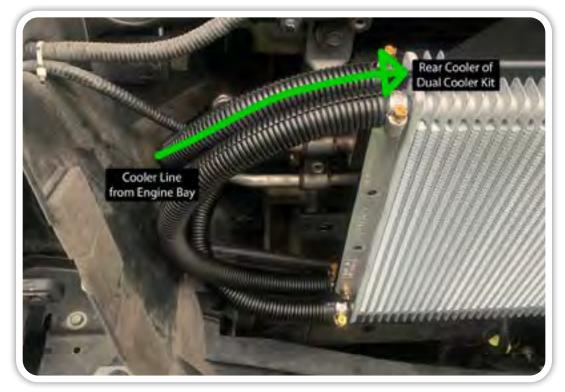
12. Fit hose that is coming from the pipe mounted on the radiator to the top of the rear cooler. Cut hose to length and use supplied new hose clamp.

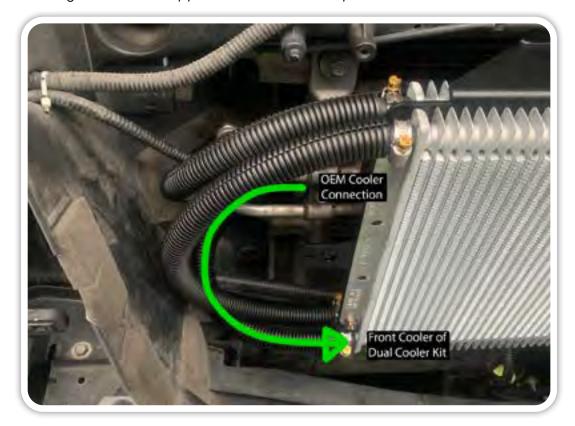
13. Fit hose that is on the OEM transmission cooler to the bottom of the front cooler. Cut hose to length and use supplied new hose clamp.

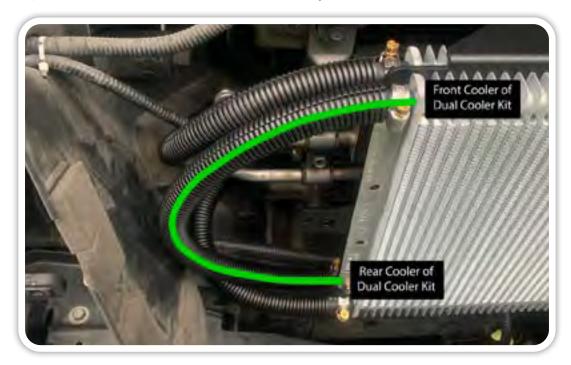
14. Fit supplied 500mm Dual Cooler link hose to join the front cooler to the rear cooler.

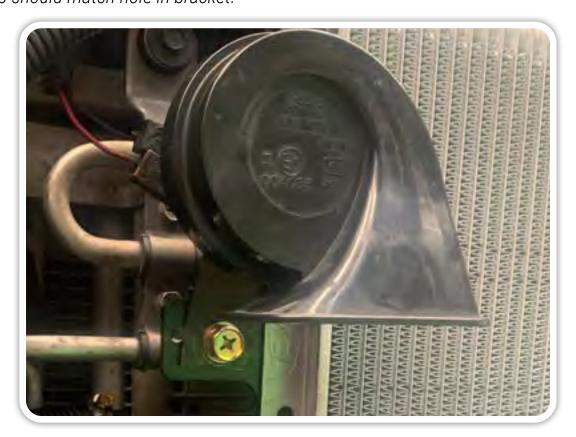
15. Before refitting horn, loosen 10mm nut on the horn and rotate bracket 180° and retighten. (Horn outlet needs to be facing down to prevent the chance of water ingress). Then mount horn to the new cooler bracket with supplied M8x20 SEMS bolt. The locator tab should match hole in bracket.

- Mount horn to the new cooler bracket with supplied M8x20 SEMS bolt.
- Refit battery tray and battery.
- Check transmission oil level
- Check for leaks
- Refit grill.

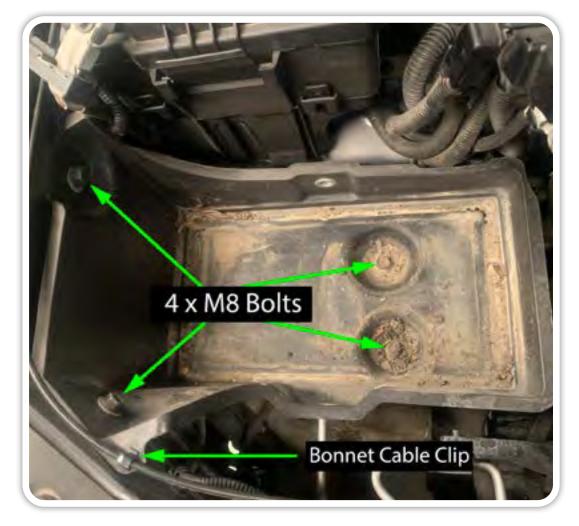
16. Refit battery tray and battery.

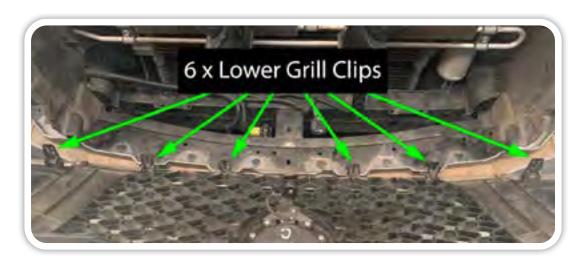
- 17. Start engine and leave transmission in Park position.
- 18. Verify there are no leaks coming from any of the connections. If no leaks detected, refit front grill and top radiator shroud by pushing the lower grill clips in first.

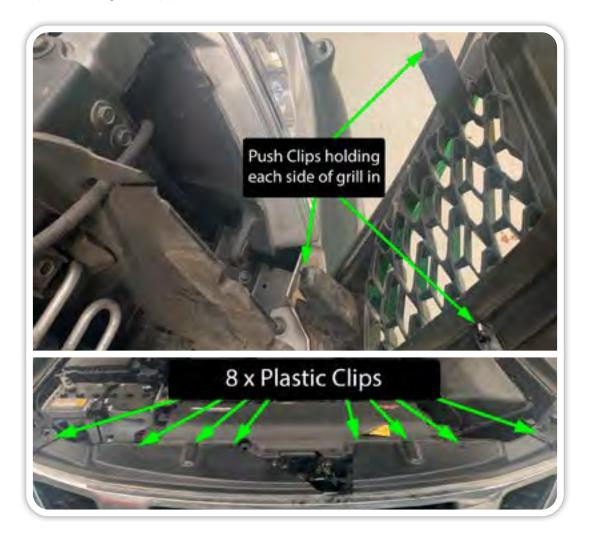
19. Then push fit the remaining clips on the outer edges of the grill and refit the 8 (eight) *x* grill clips holding the upper cover to the vehicle.

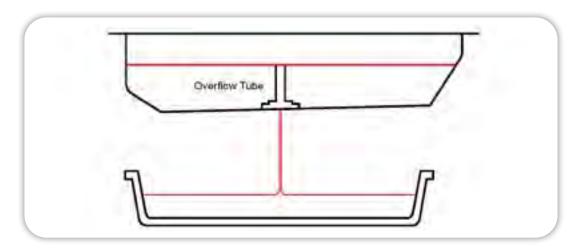
20. The Nissan Patrol Y62 RE7 transmission uses an overflow tube to provide the correct transmission fluid level. This overflow tube is located at the front of the transmission pan and is accessed via the 5mm hex bolt.

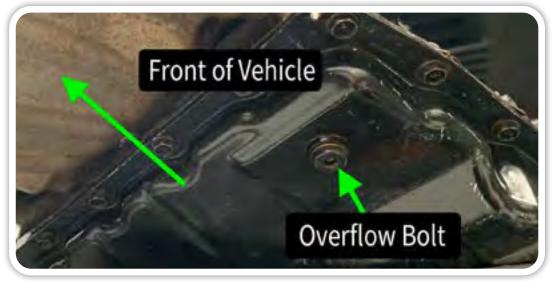
21. Once the engine has been running for at least 1 minute, move a drain tin into place under the overflow outlet and then remove the 5mm hex bolt.

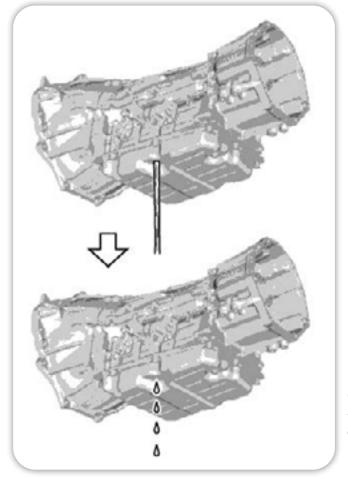
22. If the transmission fluid starts to flow out of the overflow tube in a light but steady stream (as indicated in the image below), then there is sufficient fluid inside the transmission. Wait until it slows to a dribble and re-install the overflow bolt. You can now skip to Step 26.

IMAGE IS NOT OF THE NISSAN RE7 TRANSMISSION. THE IMAGE IS TO ILLUSTRATE THE FLOW OF TRANSMISSION FLUID.

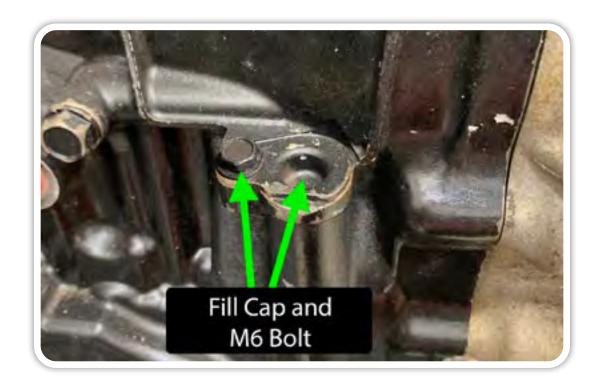
- 23. If there is no fluid flowing/dribbling from the overflow OR there was a small amount of fluid to start with but then stops, this indicates you need to add transmission fluid.
- **24.** To add fluid, remove the M6 bolt holding a cap over the fill hole just above the front of the pan on the drivers side. Add fluid until there is a light but steady dribble out of the overflow tube. If you add too much and you get a stream of fluid, wait until it slows to a dribble.

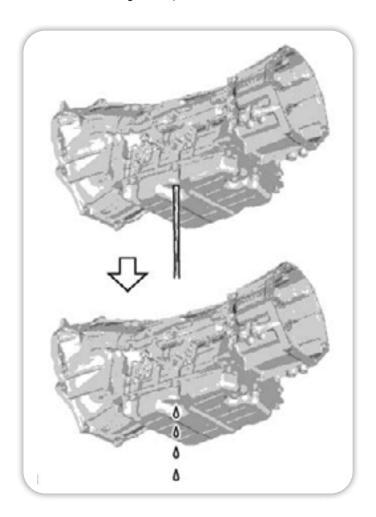
- 28. If there is no fluid flowing/dribbling from the overflow OR there was a small amount of fluid to start with but then stops, you have most likely cleared some air pockets and will need to add more transmission fluid. Return to Step 24.
- 29. If the transmission fluid starts to flow out of the overflow tube in a light but steady stream (as indicated in the image below), then there is sufficient fluid inside the transmission. Wait until it slows to a dribble and re-install the overflow bolt. Re-install the fill cap and bolt if these were removed during this process.
